## August 26, 2014 Incident

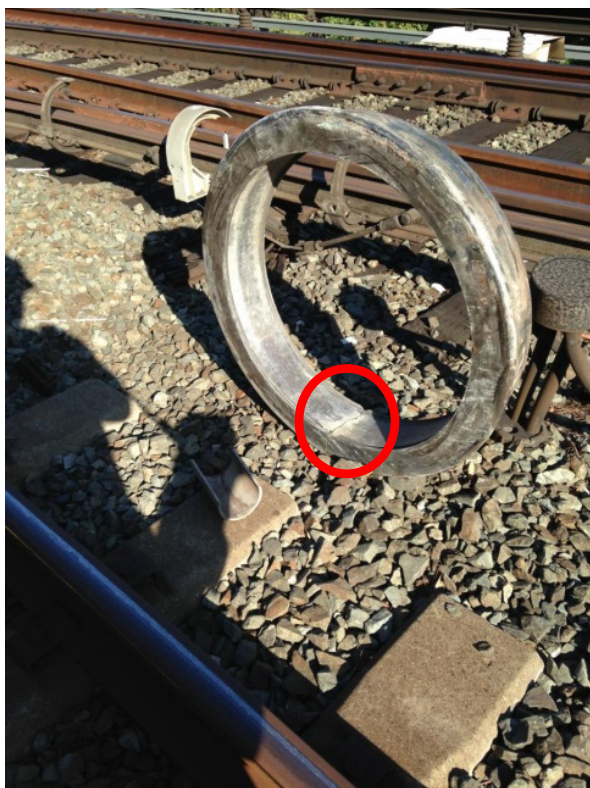
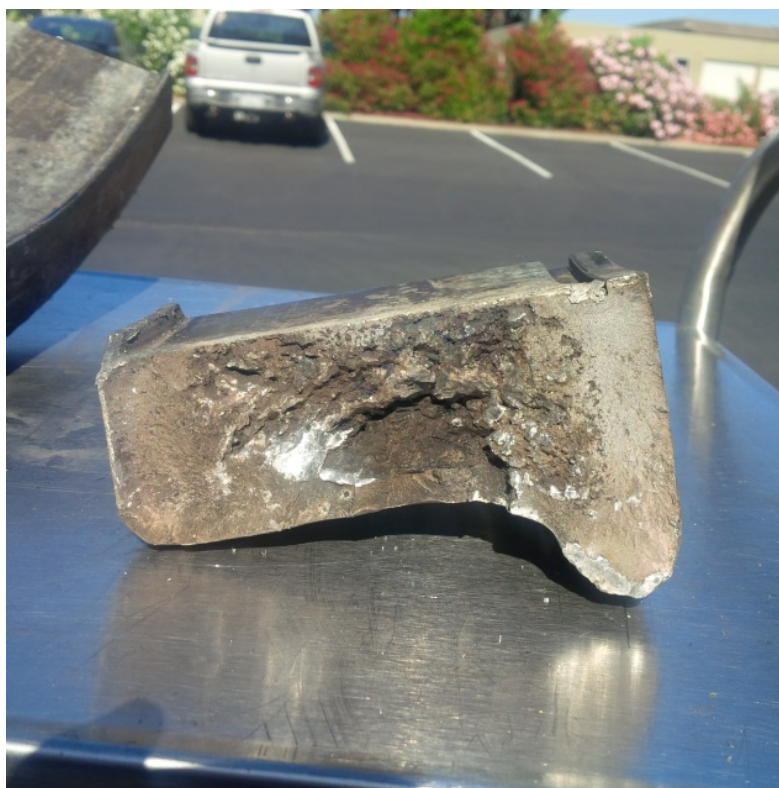
On Tuesday August 26, 2014 a steel tire came off car 1771 on the Bay Point line. Fortunately, the train did not derail, but the runaway tire caused significant damage to multiple cars on the train and the wayside; ripping up ties and the third rail. The tire had a through-crack (red circled area on picture below) which made it lose its shrink-fit, separate from the wheel hub and depart the train. The BART wheel is made up of a steel tire heat shrunk onto an aluminum hub. BART purchases the wheel as an assembled tire and hub. All of the wheels currently on the BART fleet were supplied by Penn Machine Company (PMC). The failed wheel had been in service for just under one year. It had never been cut and was only slightly smaller than a new wheel.

On Wednesday an independent third party lab, Anamet of Hayward, cut out sections of the failed tire on either side of the fracture so that the break was exposed and visible (pictured above). The fracture showed significant voids in the steel tire. Ultrasonic testing performed by Anamet showed that about a third of the tire was sprinkled with voids. It was apparent that visual inspection could not have identified this problem prior to the catastrophic failure.

- The tire broke catastrophically, as opposed to breaking from fatigue across the defect.
- The metallurgical chemistry of the tire's steel is correct to the specification.
- The defect formed as a result of rolling (the process used to form the tire) the tire at too high a temperature (while ring was still molten inside).
