## August 26, 2014 Incident

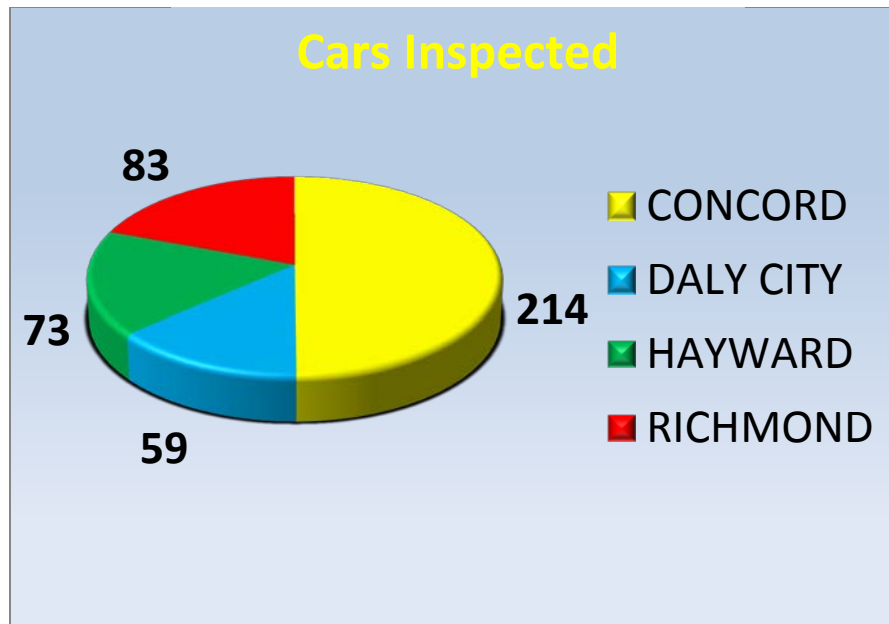
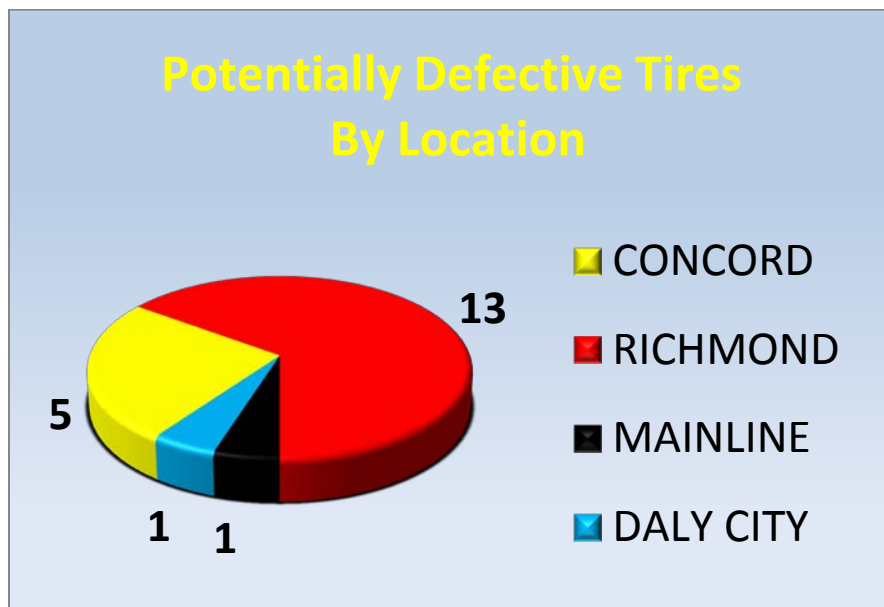
As of 8:00 this morning, Friday September 5, 429 cars (3,432 wheels) and 170 of the wheels stock have been ultrasonically tested. We will work hard to complete inspection on the remaining cars and wheels by early next week. So far a total of 20 potentially defective wheels from 12 separate heat batches have been identified. Seven of these wheels were from the original heat batch.

The following are graphical representations of the number of cars that have been inspected by shop location and where potentially defective wheels have been identified. It is evident that the investment made in the expansion of the Concord Shop with the installation of six car lifts, has proven to be a wise investment and has provided capacity to allow for quicker more efficient inspection activity.
